NSF-2025
SYNOPSIS OF PROJECT REPORT

Project Title: “**Self-Healing 2.0 – Self Healing Roads Using *Bacillus subtilis* Bacteria and Bio-Resin Capsules**”

National Science Fair Research Paper

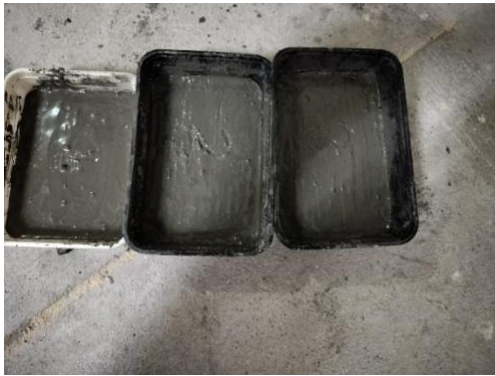
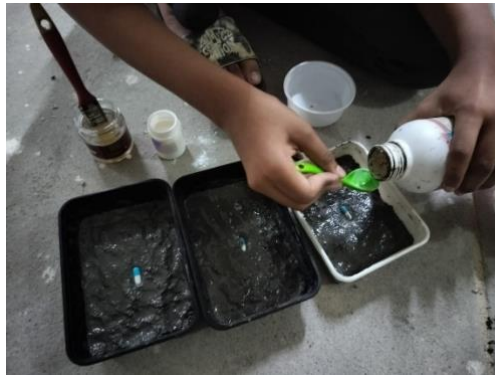
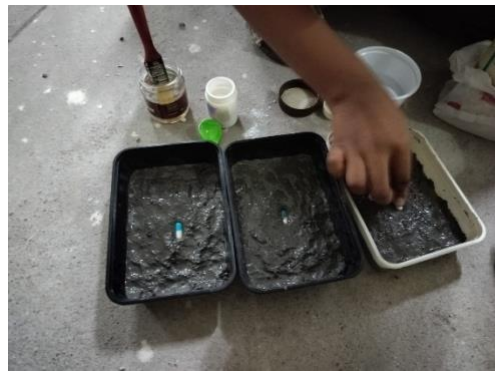
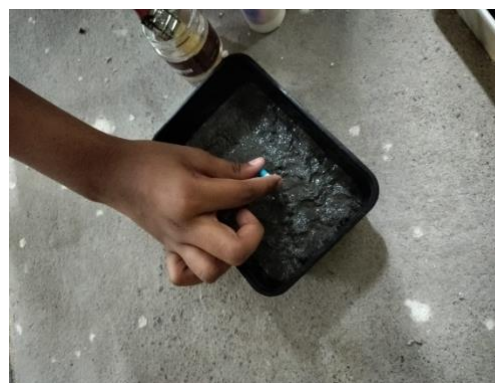
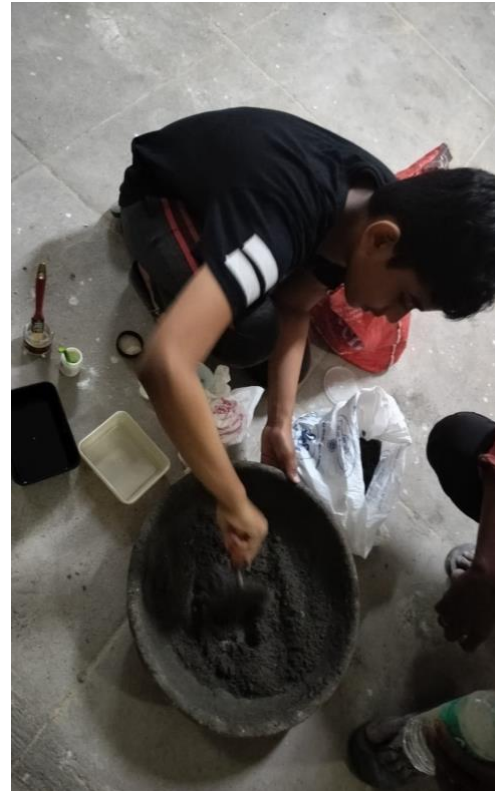
EXPERIMENTAL PICTURES:

Daily observations were made to monitor visible healing. The control sample showed minimal change, while the bacterial concrete developed white crystalline deposits after approximately four days, indicating CaCO_3 formation. Crack widths were recorded daily, and photographs were taken to document progress.

- The bacterial concrete samples showed visible changes within a few days. By the fourth day, small white spots appeared inside the cracks, which later grew into solid white crystalline deposits.

- By the tenth day, approximately 85–90% of the cracks in the bacterial concrete had closed completely. The healed areas appeared smooth and firm to the touch.
